**Flood Control Project Maintenance
Levee Inspections**
LMA District Cover Sheet
Spring 2017 Levee Inspection Results

Butte County Department of Public Works

Spring 2017 Levee Inspection Results

Waterway			Bank	Unit Miles
Unit No. 01 Mud Creek			Right	6.80
	Spring (March - May)	Summer (June - August)	(September - November) Fall	Winter (December - February)
Unit Maintenance Rating (Fall Only)				
Date of Inspection	4/20/2017 - 4/20/2017			
DWR Inspector	Bob Duffey			
Accompanied By	Shawn Bates Butte County

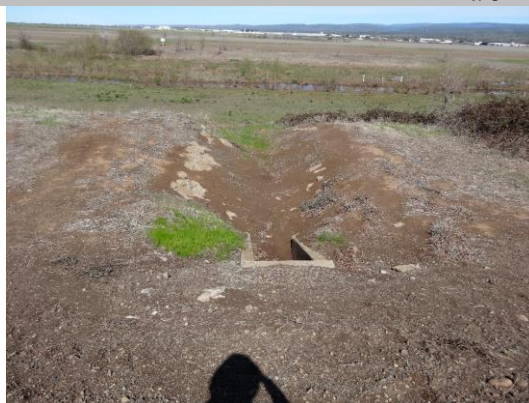
Photo 1 of 3 : UCIP_SP_2017_32026_58520.jpg

LM Start	0.27	Rating **	M	Issue No.	25
LM End	0.27	Issue Type +	Ma	Location *	LS
Category	Supplemental			GPS Latitude/Longitude	
				Start	End
Item	DWR UCIP LMA Responsibility			39.776554 °	39.776554 °
				-121.850730 °	-121.850730 °
DWR ID					
Comment Code					
Inspector Comment					
FS_ID:32026 DS_ID:19279 EP_NO: N/A Repair Type: Non-Urgent Crossing Status: Found UCIP Comments: Needs cleaning and clearing the culvert. FIELD_STRUCT_DESC: 24-inch CM pipe through the levee, 10.0 feet below the crown. Flap gate on the waterward end. Concrete "U" headwalls on both ends. Grouted riprap apron on the landward end. Grouted riprap spillway on the waterward end. O&M Manual Sac 504, May 1965. FS Date: 3/7/2014

WS view: concrete headwall and grouted riprap spillway on levee slope.

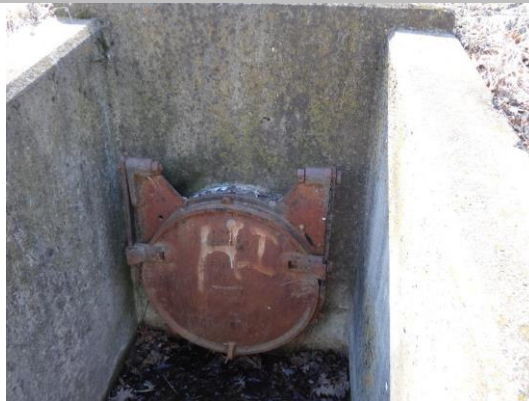
Photo 1 of 2 : UCIP_SP_2017_32143_58641.jpg

FS_ID:32143
DS_ID:19287
EP_NO: N/A
Repair Type: Non-Urgent
Crossing Status: Found
UCIP Comments: Needs cleaning and clearing the culvert.
FIELD_STRUCT_DESC: 24-inch CM pipe through the levee, 9.0 feet below the crown. Flap gate on the waterward end. Concrete "U" headwalls on both ends. Grouted riprap apron on the landward end. Grouted riprap spillway on the waterward end. O&M Manual Sac 504, May 1965.
FS Date: 3/7/2014

WS view: U type concrete headwall and CMP on levee slope. Soil/mud on outlet box. Needs cleaning and clearing.

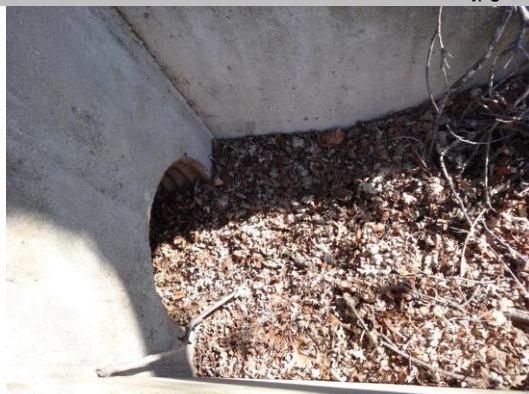
Photo 2 of 2 : UCIP_SP_2017_32143_58640.jpg

LS view: U type concrete headwall and CMP on levee slope. Vegetation and mud on inlet box.

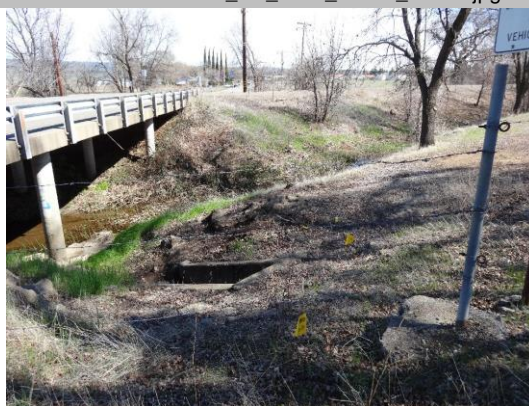
Photo 1 of 2 : UCIP_SP_2017_31946_58357.jpg

LM Start	0.92	Rating **	M	Issue No.	29
LM End	0.92	Issue Type +	En	Location *	LS
Category	Supplemental			GPS Latitude/Longitude	
				Start	End
Item	DWR UCIP Field Study			39.775729 °	39.775729 °
				-121.850950 °	-121.850950 °
DWR ID					
Comment Code					
Inspector Comment					
FS_ID:31946					
DS_ID:19293					
EP_NO: 15950					
Repair Type: Non-Urgent					
Crossing Status: Indicator Found					
UCIP Comments: Only little gasoline indicator flags found on both sides of the levee and across the creek.					
FIELD_STRUCT_DESC: 6-inch-diameter high pressure gas main line under both levees and across channel of Dry Creek. 2 feet below the crown. Application No. 15950, 1992.					
FS Date: 3/7/2014

WS view: little gasoline indicator (yellow flags) on both sides of the levee.

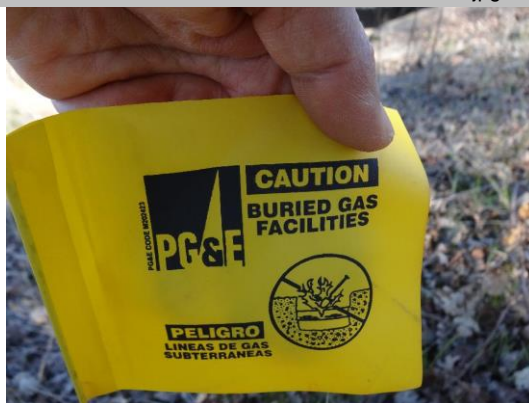
Photo 2 of 2 : UCIP_SP_2017_31946_58356.jpg

WS view: close up view of little gasoline indicator.

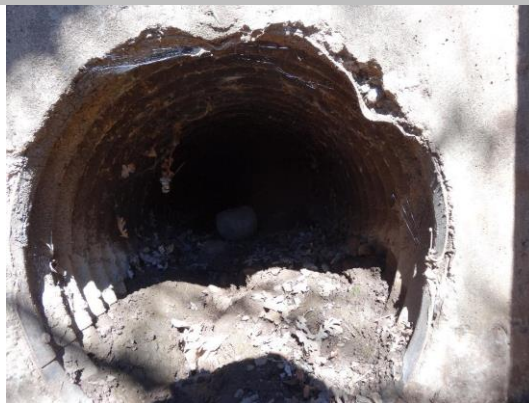
Photo 3 of 3 : UCIP_SP_2017_31963_58385.jpg

LS view: inside view of CMP on levee slope. Needs cleaning and clearing.

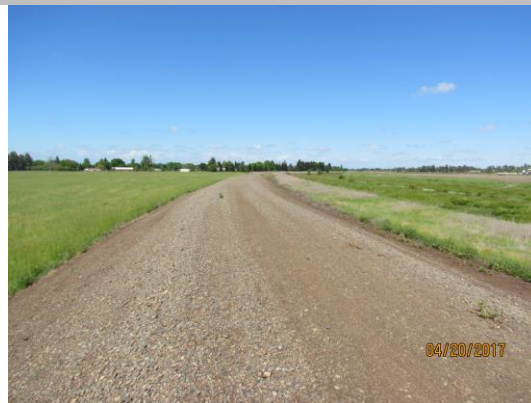
Photo 1 of 1 : SP_2017_NA0003_68_16_20170426_00038.jpg

LM Start	1.56	Rating **	A	Issue No.	16
LM End	1.56	Issue Type +	Ma	Location *	LS
Category	Earthen Levee			GPS Latitude/Longitude	
				Start	End
Item	Vegetation			39.778610 °	39.778610 °
				-121.861735 °	-121.861735 °
DWR ID	DWR_NA0003_04_s_2017_16				
Comment Code					
V1 : Control annual grass and weeds on the levee slopes and easements.					
Inspector Comment

View of no vegetation on both slopes.

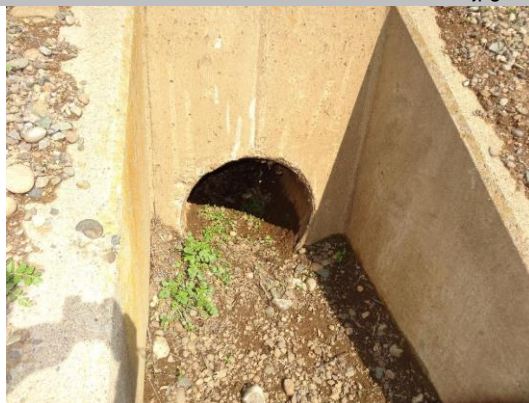
Photo 2 of 3 : UCIP_SP_2017_31965_58394.jpg

LS view: U type concrete headwall and CMP on levee slope. Vegetation debris and mud in inlet box.

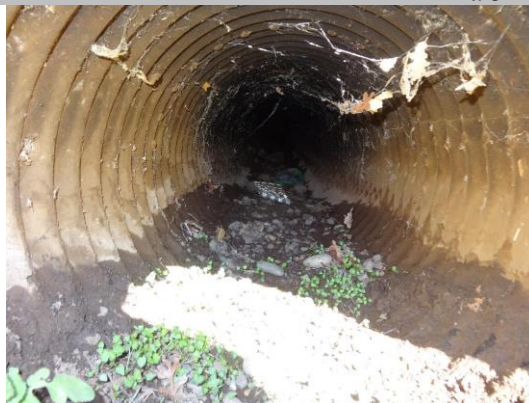
Photo 3 of 3 : UCIP_SP_2017_31965_58393.jpg

LM Start	2.15	Rating **	M	Issue No.	33 (cont)	
LM End	2.15	Issue Type +	Ma	Location *	LS	
Category	Supplemental			GPS Latitude/Longitude		
				Start	End	
Item	DWR UCIP LMA Responsibility			39.782777 °	39.782777 °	
				-121.871179 °	-121.871179 °	
DWR ID						
Comment Code						
Inspector Comment						
FS_ID:31965						
DS_ID:19291						
EP_NO: N/A						
Repair Type: Non-Urgent						
Crossing Status: Found						
UCIP Comments: Needs cleaning and clearing the culvert.						
FIELD_STRUCT_DESC: 24-inch CM pipe through the levee, 11.0 feet below the crown. Flap gate on the waterward end. Concrete "U" headwall on both ends. Grouted riprap apron on the landward end. Grouted riprap spillway on the waterward end. O&M Manual Sac 504, May 1965.						
FS Date: 3/7/2014

LS view: inside view of CMP on levee slope. Needs cleaning and clearing.

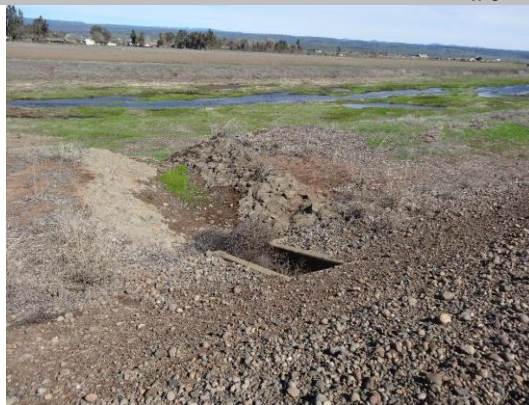
Photo 1 of 3 : UCIP_SP_2017_31966_58401.jpg

LM Start	2.47	Rating **	M	Issue No.	34
LM End	2.47	Issue Type +	Ma	Location *	LS
Category	Supplemental			GPS Latitude/Longitude	
				Start	End
Item	DWR UCIP LMA Responsibility			39.784244 °	39.784244 °
				-121.876810 °	-121.876810 °
DWR ID					
Comment Code					
Inspector Comment					
FS_ID:31966					
DS_ID:19292					
EP_NO: N/A					
Repair Type: Non-Urgent					
Crossing Status: Found					
UCIP Comments: Needs cleaning and clearing the culvert.					
FIELD_STRUCT_DESC: 24-inch CM pipe through levee, 11.0 feet below the crown. Flap gate on the waterward end. Concrete "U" headwalls on both ends. Grouted riprap apron on the landward end. Grouted riprap spillway on the waterward end. O&M Manual Sac 504, May 1965.					
FS Date: 3/7/2014

WS view: U type concrete headwall and grouted riprap spillway on levee slope.

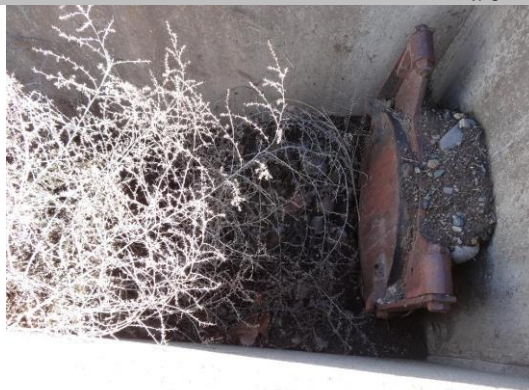
Photo 2 of 3 : UCIP_SP_2017_31966_58400.jpg

LM Start	2.47	Rating **	M	Issue No.	34 (cont)	
LM End	2.47	Issue Type +	Ma	Location *	LS	
Category	Supplemental			GPS Latitude/Longitude		
				Start	End	
Item	DWR UCIP LMA Responsibility			39.784244 °	39.784244 °	
				-121.876810 °	-121.876810 °	
DWR ID						
Comment Code						
Inspector Comment						
FS_ID:31966						
DS_ID:19292						
EP_NO: N/A						
Repair Type: Non-Urgent						
Crossing Status: Found						
UCIP Comments: Needs cleaning and clearing the culvert.						
FIELD_STRUCT_DESC: 24-inch CM pipe through levee, 11.0 feet below the crown. Flap gate on the waterward end. Concrete "U" headwalls on both ends. Grouted riprap apron on the landward end. Grouted riprap spillway on the waterward end. O&M Manual Sac 504, May 1965.						
FS Date: 3/7/2014

WS view: U type concrete headwall and CMP on levee slope. Vegetation debris and mud on outlet box. Needs cleaning and clearing.

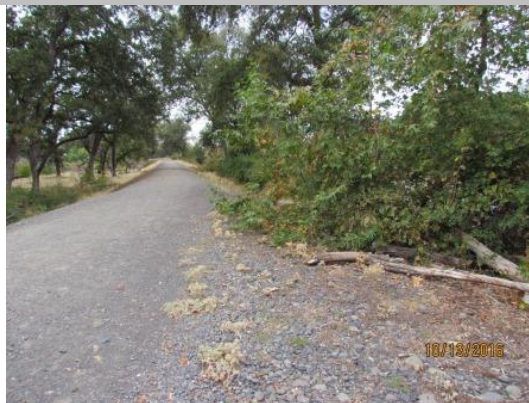
Photo 1 of 1 : SP_2017_NA0003_69_4_20170315_00002.jpg

LM Start	0.21	Rating **	M	Issue No.	4
LM End	0.26	Issue Type +	Ma	Location *	WS
Category	Earthen Levee			GPS Latitude/Longitude	
				Start	End
Item	Vegetation			39.761957 °	39.761892 °
				-121.792867 °	-121.793705 °
DWR ID	DWR_NA0003_05_f_2014_4				
Comment Code					
V2 : Remove the wild growth other than native grasses from the levee slopes.					
Inspector Comment					
Remove the vegetation from the waterside slope.

View of the vegetation along the waterside slope.

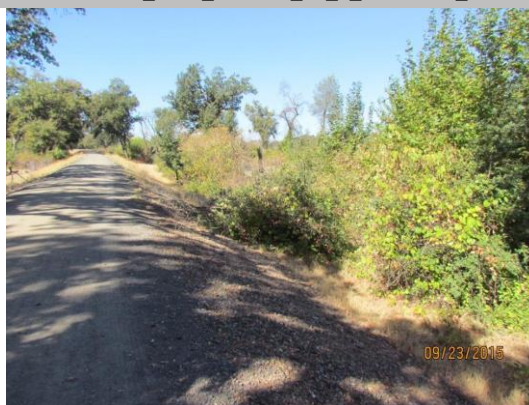
Photo 1 of 1 : SP_2017_NA0003_69_7_20170315_00003.jpg

LM Start	0.25	Rating **	M	Issue No.	7
LM End	0.25	Issue Type +	En	Location *	WS
Category	Earthen Levee			GPS Latitude/Longitude	
				Start	End
Item	Encroachments			39.761900 °	39.761900 °
				-121.793635 °	-121.793635 °
DWR ID	DWR_NA0003_05_f_2015_7				
Comment Code					
TR : Tree or limb					
Inspector Comment					
Remove the trees overhanging the waterside slope.

View of the trees along the waterside slope.

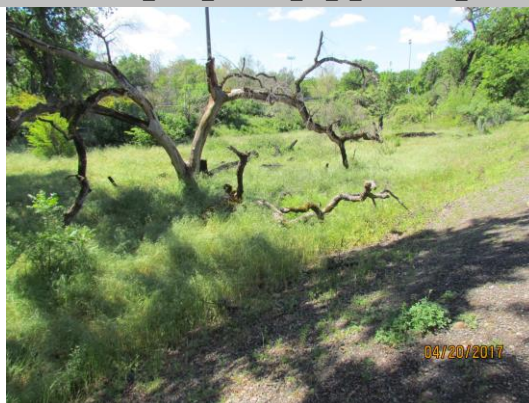
Photo 1 of 2 : SP_2017_NA0003_69_8_20170426_00009.jpg

LM Start	0.26	Rating **	M	Issue No.	8
LM End	0.26	Issue Type +	En	Location *	LS
Category	Earthen Levee			GPS Latitude/Longitude	
				Start	End
Item	Encroachments			39.761795 °	39.761795 °
				-121.793790 °	-121.793790 °
DWR ID	DWR_NA0003_05_f_2015_8				
Comment Code					
TR : Tree or limb					
Inspector Comment					
Remove the trees from the landside toe.

View of the tree along the landside toe that has not been removed for over a year.

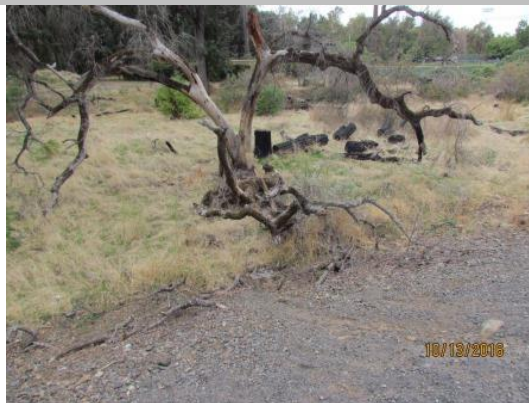
Photo 2 of 2 : SP_2017_NA0003_69_8_20170315_00004.jpg

LM Start	0.26	Rating **	M	Issue No.	8 (cont)	
LM End	0.26	Issue Type +	En	Location *	LS	
Category	Earthen Levee			GPS Latitude/Longitude		
				Start		End
Item	Encroachments			39.761795 °		39.761795 °
				-121.793790 °		-121.793790 °
DWR ID	DWR_NA0003_05_f_2015_8					
Comment Code						
TR : Tree or limb						
Inspector Comment						
Remove the trees from the landside toe.

View of the trees along the landside toe.

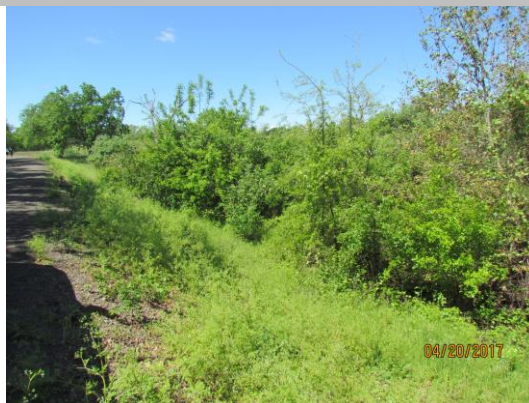
Photo 1 of 1 : SP_2017_NA0003_69_9_20170426_00012.jpg

LM Start	0.33	Rating **	M	Issue No.	9
LM End	0.33	Issue Type +	Ma	Location *	WS
Category	Earthen Levee			GPS Latitude/Longitude	
				Start	End
Item	Vegetation			39.761642 °	39.761642 °
				-121.795008 °	-121.795008 °
DWR ID	DWR_NA0003_05_s_2017_9				
Comment Code					
V2 : Remove the wild growth other than native grasses from the levee slopes.					
Inspector Comment

View of the vegetation along the waterside slope and toe.

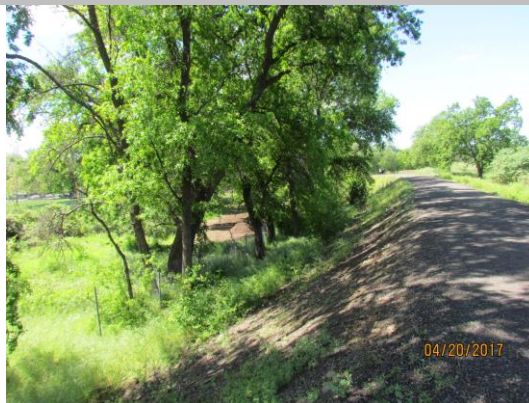
Photo 1 of 2 : SP_2017_NA0003_69_3_20170426_00010.jpg

LM Start	0.34	Rating **	M	Issue No.	3
LM End	0.42	Issue Type +	Ma	Location *	LS
Category	Earthen Levee			GPS Latitude/Longitude	
				Start	End
Item	Vegetation			39.761633 °	39.761117 °
				-121.795155 °	-121.796464 °
DWR ID	DWR_NA0003_05_f_2013_3				
Comment Code					
V2 : Remove the wild growth other than native grasses from the levee slopes.					
Inspector Comment

View of the vegetation along the landside slope and toe.

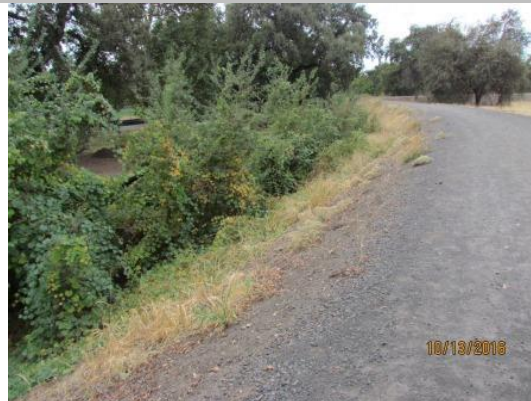
Photo 2 of 2 : SP_2017_NA0003_69_3_20170315_00001.jpg

LM Start	0.34	Rating **	M	Issue No.	3 (cont)	
LM End	0.42	Issue Type +	Ma	Location *	LS	
Category	Earthen Levee			GPS Latitude/Longitude		
				Start		End
Item	Vegetation			39.761633 °		39.761117 °
				-121.795155 °		-121.796464 °
DWR ID	DWR_NA0003_05_f_2013_3					
Comment Code						
V2 : Remove the wild growth other than native grasses from the levee slopes.						
Inspector Comment

View of the vegetation along the landside slope and toe.

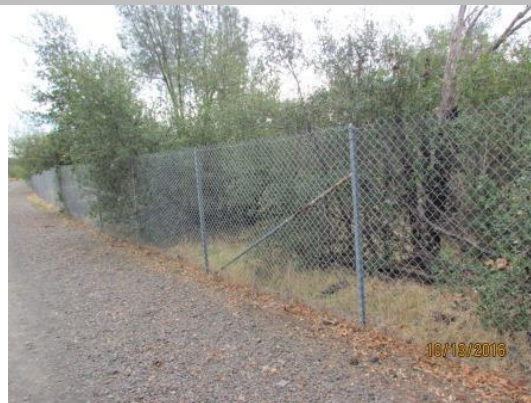
Photo 1 of 1 : SP_2017_NA0003_69_12_20170315_00006.jpg

LM Start	0.50	Rating **	M	Issue No.	12
LM End	0.82	Issue Type +	Ma	Location *	LS
Category	Earthen Levee			GPS Latitude/Longitude	
				Start	End
Item	Trim / Thin Trees			39.761836°	39.763507°
				-121.797316°	-121.802545°
DWR ID	DWR_NA0003_05_f_2016_12				
Comment Code					
T2 : Thin trees to allow visibility of the ground and room to flood fight.					
Inspector Comment

View of the trees along the landside slope.

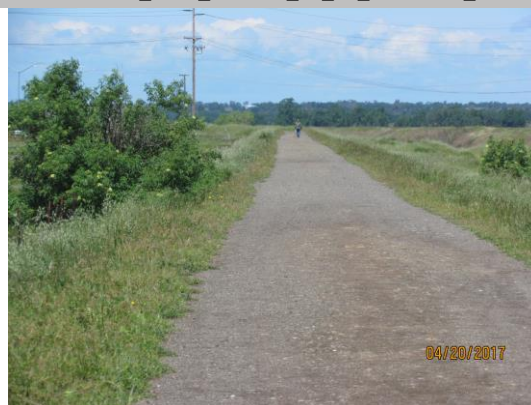
Photo 1 of 1 : SP_2017_NA0003_69_14_20170426_00013.jpg

LM Start	0.84	Rating **	A	Issue No.	14
LM End	0.84	Issue Type +	Ma	Location *	LS
Category	Earthen Levee			GPS Latitude/Longitude	
				Start	End
Item	Vegetation			39.763700 °	39.763700 °
				-121.802752 °	-121.802752 °
DWR ID	DWR_NA0003_05_s_2017_14				
Comment Code					
V1 : Control annual grass and weeds on the levee slopes and easements.					
Inspector Comment

View of the native grasses on both slopes.
